**DESTROYER ENGINEERED OPERATING CYCLE
(DDEOC)**

System Maintenance Analysis

**FF-1052 CLASS
FIREMAIN SYSTEM
SMA 203-521**

REVIEW OF EXPERIENCE

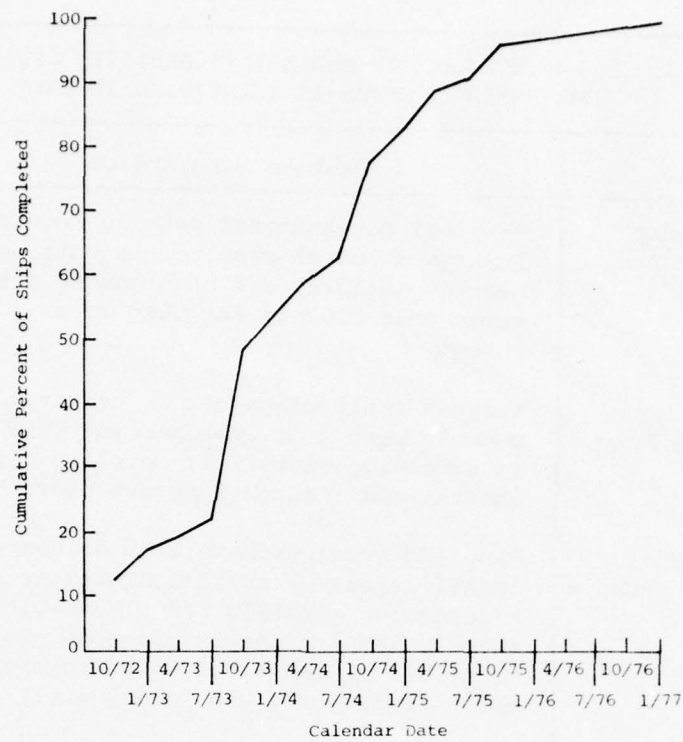
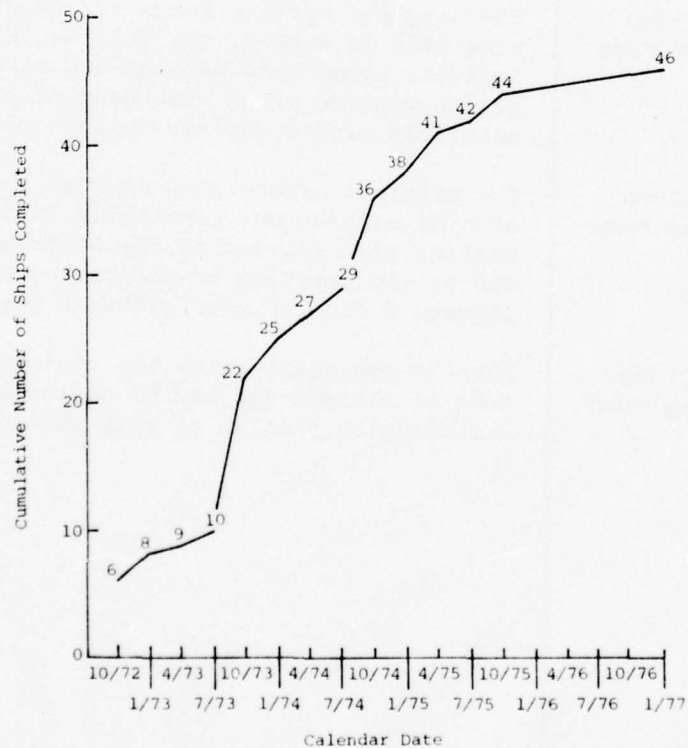
Figure 3-1. FF-1052 CLASS MECHANICAL SEAL CONVERSION CHRONOLOGY

3.2.2.1.2 Mechanical Seal Conversion. In response to bearing corrosion and motor cooling problems associated with excessive saltwater leakage, conversion of the pumps from conventional packing to mechanical seals was initiated in July 1972. APL 016150911 was to apply to the pump following completion of the conversion. However, examination of MDS and CASREP data showed that repair personnel continued to report both maintenance and casualties against the original APL 016150582 after conversion. This was established by checking the recorded APL on those transactions which specifically mentioned mechanical seals. Discussions with NAVSEC and NAVSEA personnel revealed that accurate conversion dates for particular pumps or particular ships were not available. Thus the intended distinction between APL 016150582 and APL 016150911 was not preserved, and MDS data for the two APLs were summed and analyzed together.

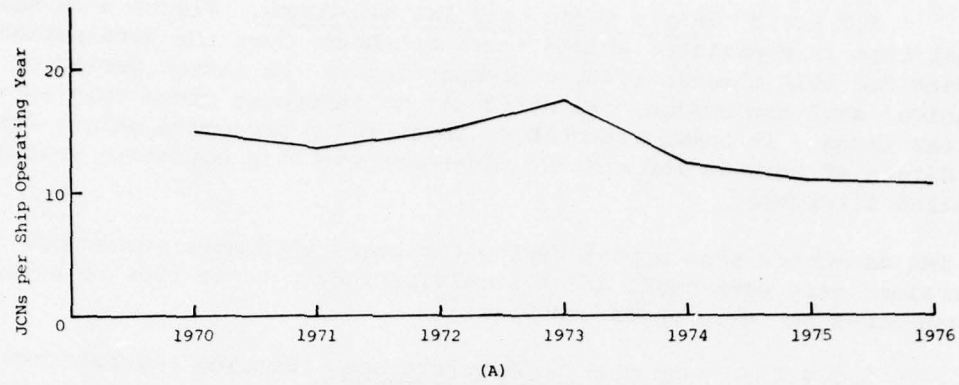
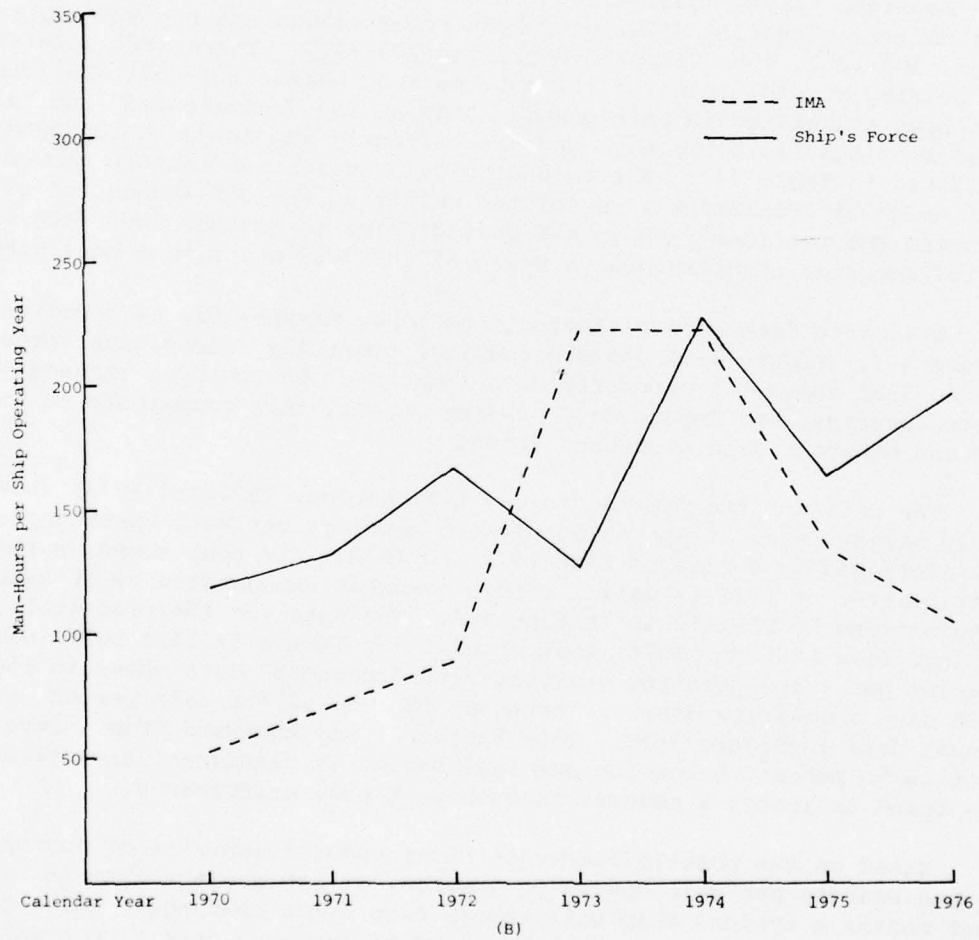
Figure 3-2. NORMALIZED MDS DATA FOR BUFFALO FORGE PUMPS BY CALENDAR YEAR

3.2.2.4.1 Number of JCNs. Figure 3-2A shows a plot by calendar year of JCNs per ship operating year submitted against the Buffalo Forge Pump. This parameter is a rough measure of repair activity for the pump over the data period examined. It should be noted that the data point for 1976, is based on data for the first 6 months of 1976 and annualized to the number of ship operating years in that 6-month period.

The plot itself shows a gradual decline in the number of job actions being reported. The peak in 1973 corresponds to the activity associated with mechanical seal conversion.

3.2.2.4.2 Ship's Force and IMA Man-Hours. Figure 3-2B shows a gradual rise in normalized ship's force man-hours over the data period. The data for 1974 through 1976, corresponding to the latter period of mechanical seal conversion, are difficult to interpret since they show no clear trend. It seems reasonable, however, to project a ship's force expenditure of between 150 and 200 man-hours per ship operating year on installed firepumps.

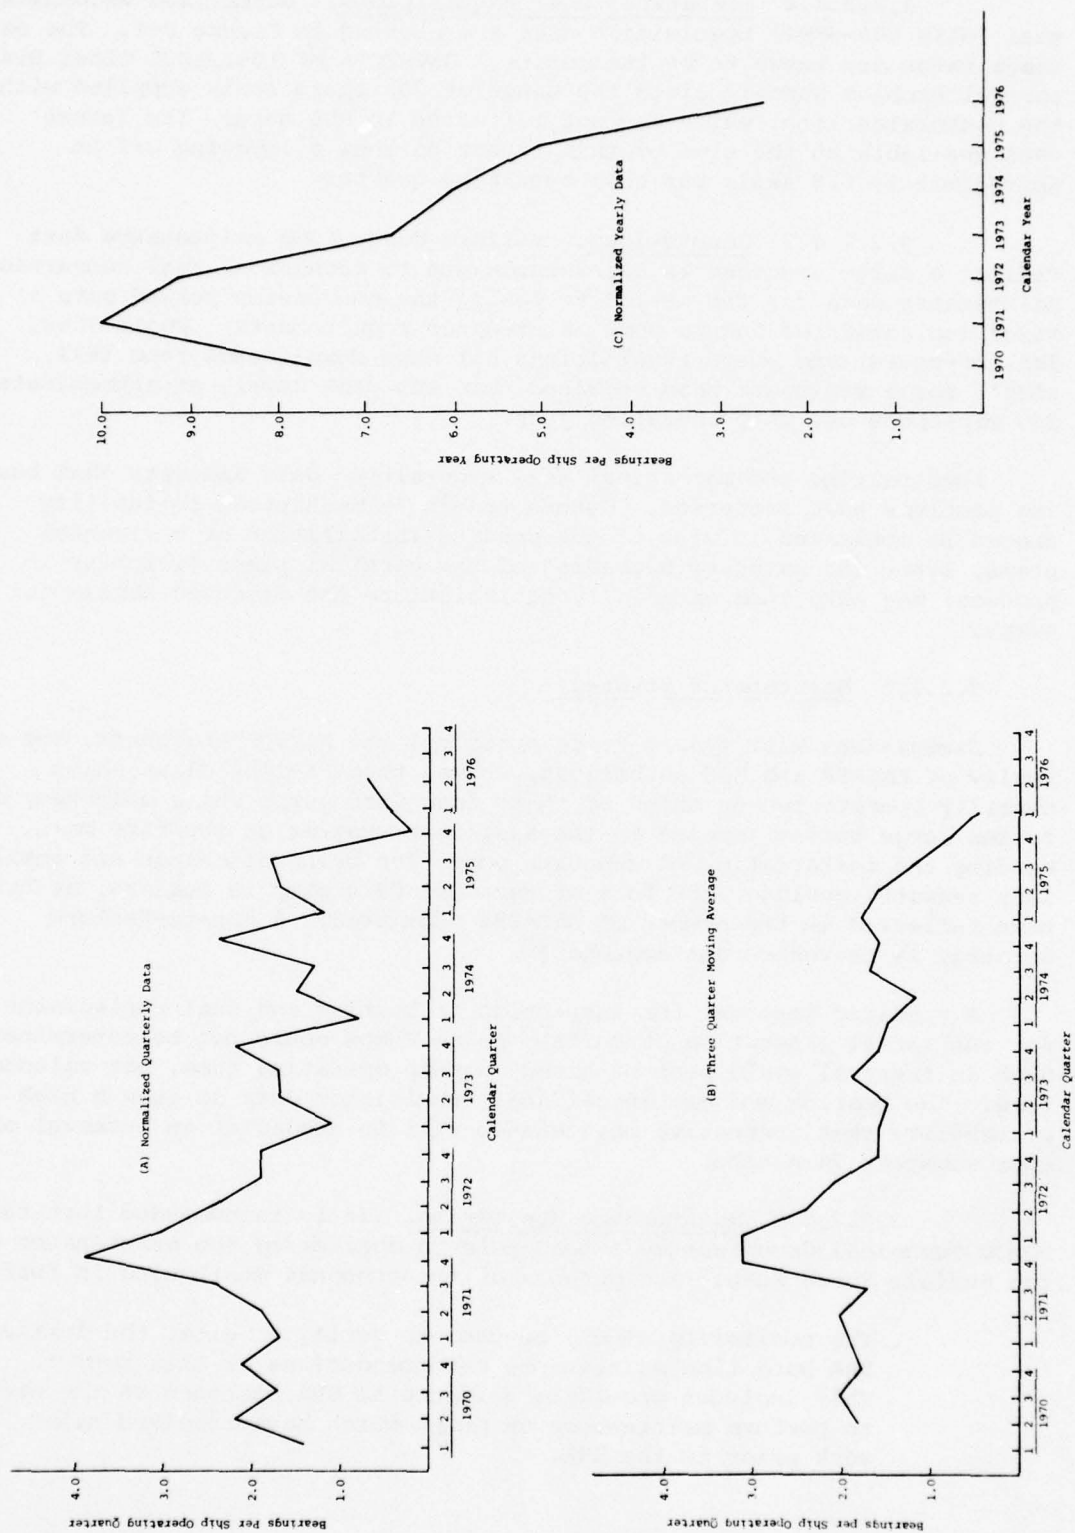
Figure 3-3. BUFFALO FORCE FIRE PUMP BEARING REQUISITION HISTORY FOR FF-1052 CLASS SHIPS

The data for the pre-mechanical seal period, 1970 and 1971, show an early steady level of approximately two bearings per ship operating quarter, followed by a rise in late 1971 and 1972. The peak shown in the last quarter of 1971 is valid, though somewhat exaggerated by 26 bearing requisitions by FF-1053 in that period. The data for the post-seal period, late 1975 and 1976, show requisition levels falling below one bearing per ship operating quarter. The "smoothed" data shown in Figure 3-3B show a definite downward trend at the end of the data period, as do annual data in Figure 3-3C. This further trend downward from a level that is 50 percent below the pre-seal period is considered significant. The trend indicates a reduced frequency of pump maintenance.

Based on the post-1975 average Fleet requisition rate of approximately one bearing per ship operating quarter, we can project that in twenty-four months a typical ship will requisition eight bearings. This corresponds to the number of bearings required to overhaul four fire pumps, indicating that the average maintenance interval for fire pumps that have been upgraded by mechanical seal installations is approximately 24 months.

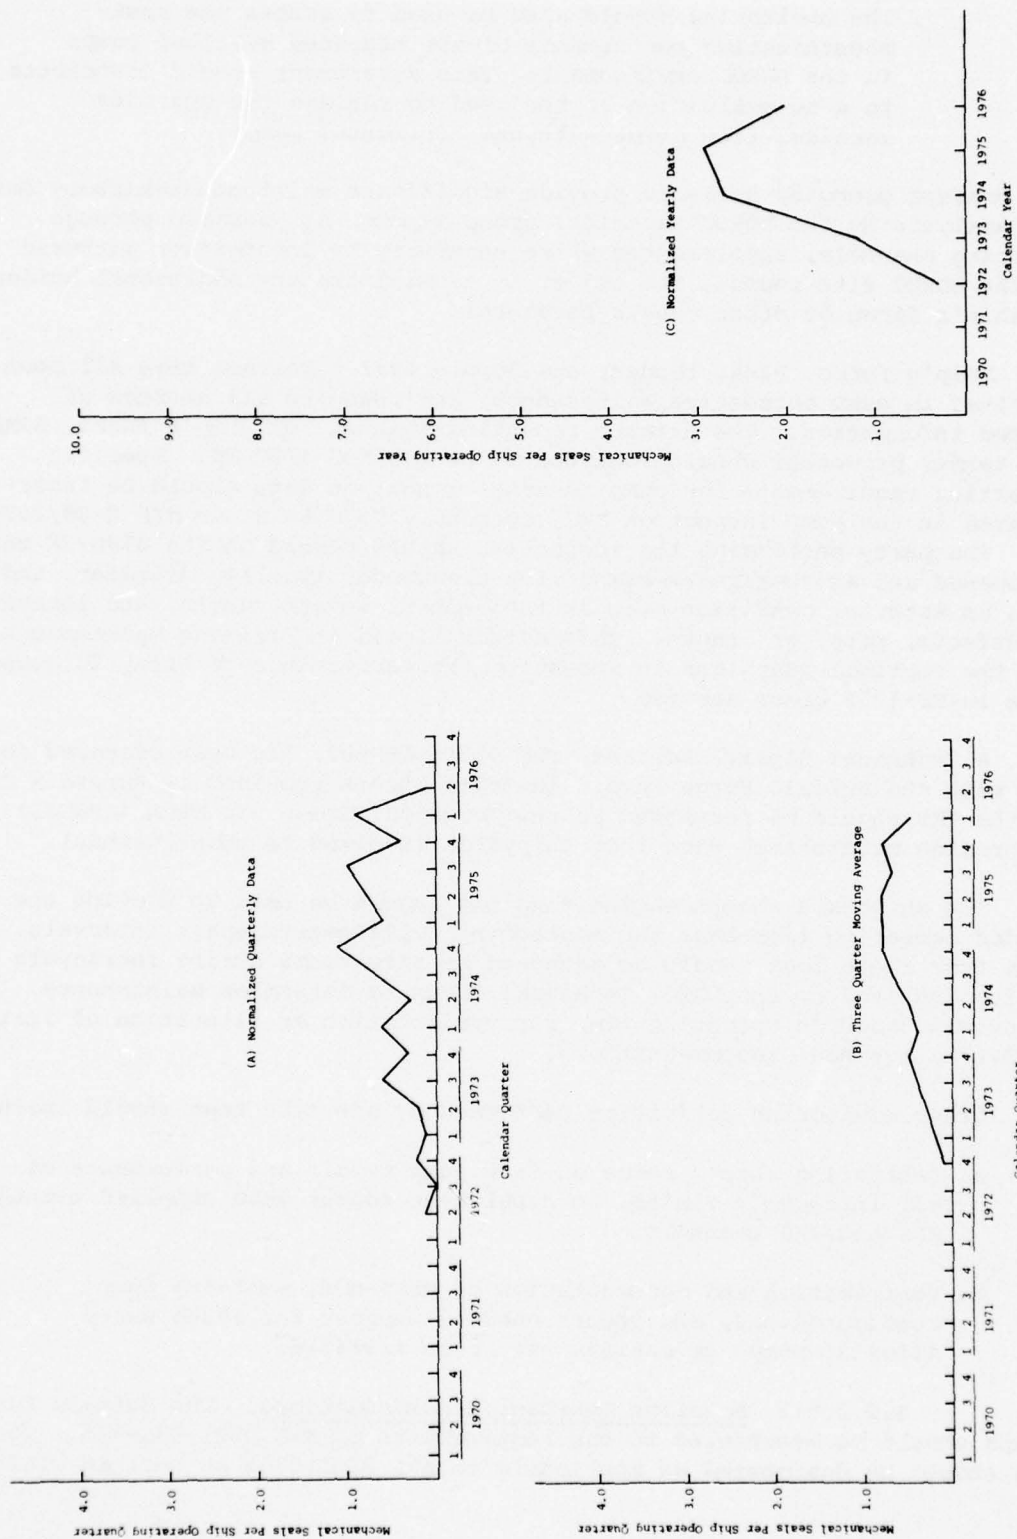
Figure 3-4. BUFFALO FORCE FIRE PUMP MECHANICAL SEAL REQUISITION HISTORY FOR
FF-1052 CLASS SHIPS

3.2.2.4.4 Mechanical Seal Requisitions. Normalized mechanical seal (NIIN 480-3894) requisition data are plotted in Figure 3-4. The early usage rates are known to be inaccurate. NAVSEC's FF-1052/1078 Class Historical Problem Summary cited the usage of 208 spare seals supplied with the conversion kits, which was not reflected in MDS data. The latest data available at the time of this report do show a leveling off at approximately 0.8 seals per ship operating quarter.

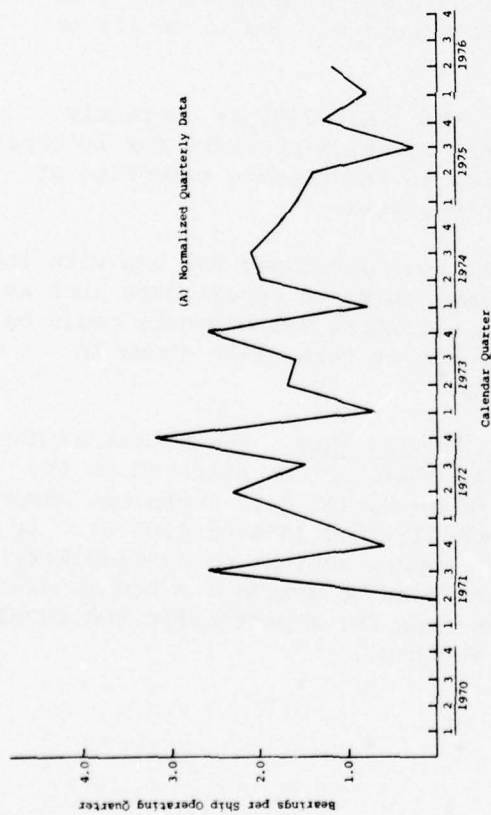
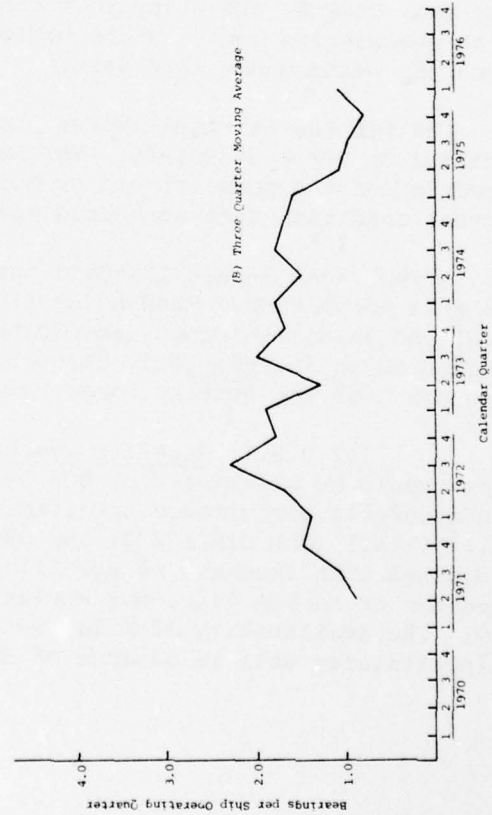
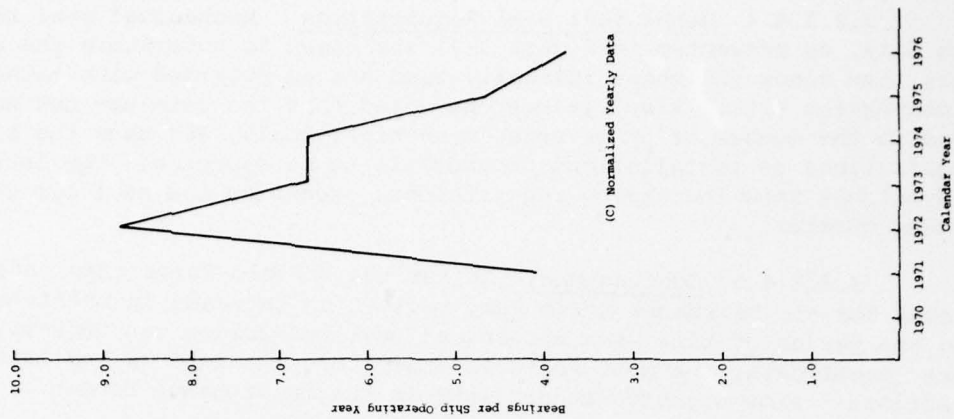
Figure 3-6. FAIRBANKS MORSE FIRE PUMP BEARING REQUISITION HISTORY FOR FF-1052 CLASS SHIPS

3.2.3.4.3 Pump Bearing Requisitions. Two bearing stock numbers have been reported against the Fairbanks Morse Pump: 144-8657 and 555-5207 which are the "alternate" and "recommended" bearings, respectively. The data of Figure 3-6 show a decline of about 50 percent from peak requisition levels of approximately two bearings per ship operating quarter. The corresponding decline using yearly data is from slightly less than nine to approximately four bearings per ship operating year. The data for 1976 indicate that the decline is leveling off.

As with the Buffalo Forge Pump, a requisition rate for Fairbanks Morse Pump bearings of one bearing per ship operating quarter indicates an average pump maintenance interval of twenty-four months. This again is based on the latest data available, chosen to reflect the requirements of pumps converted to mechanical seals.

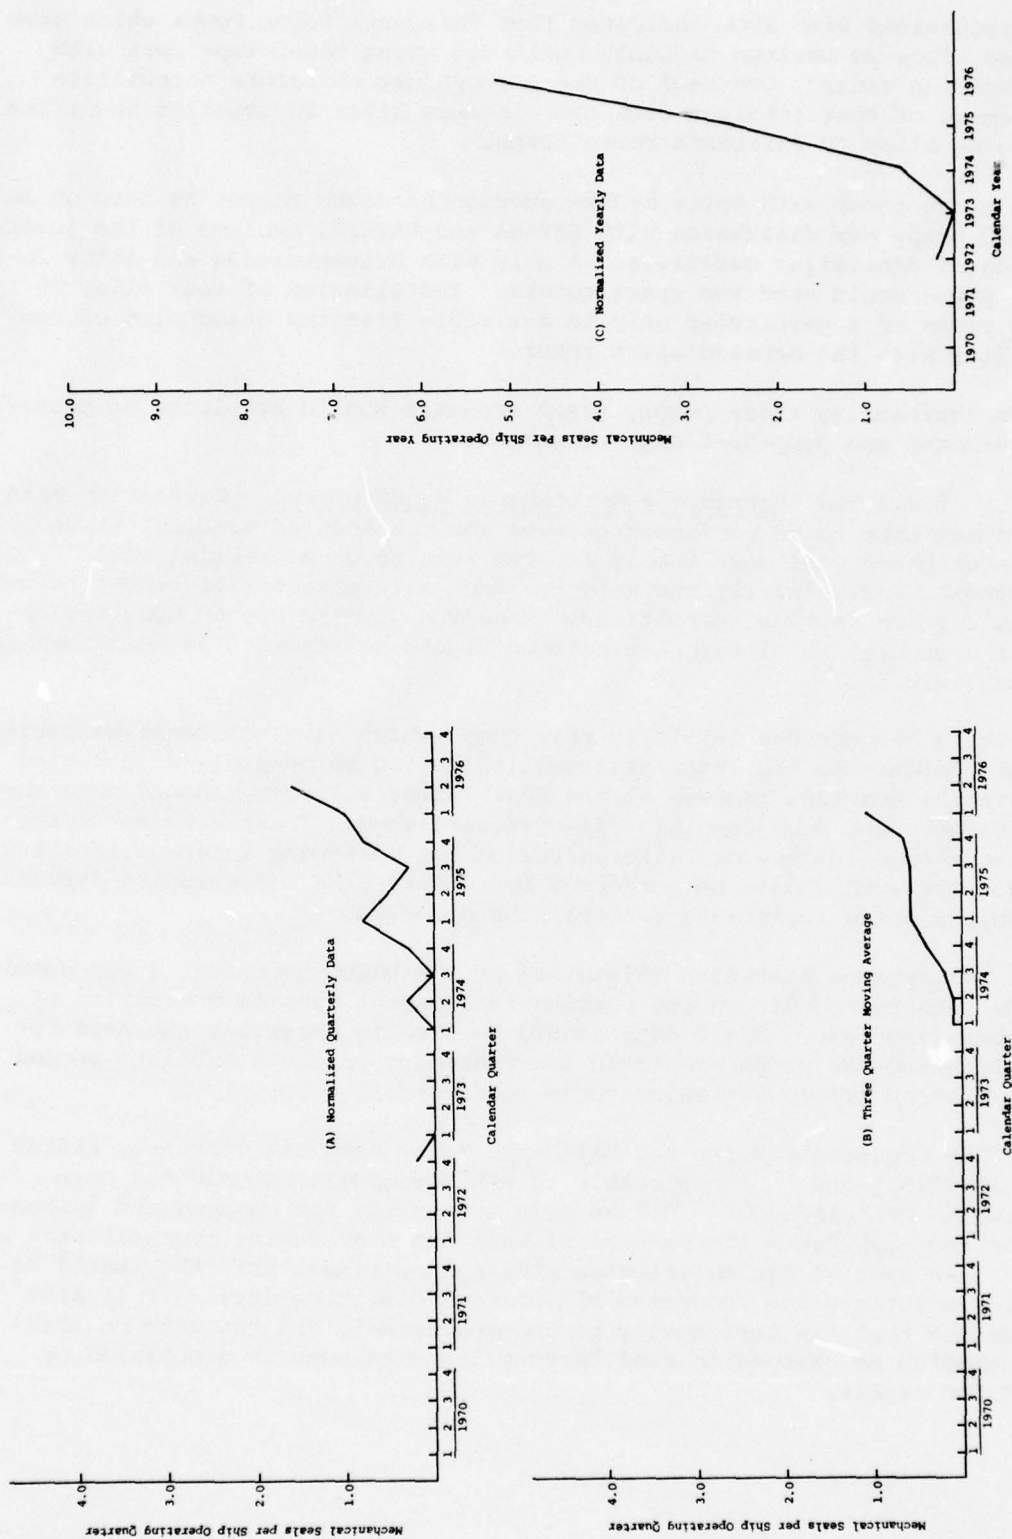
Figure 3-7. FAIRBANKS MORSE FIRL PUMP MECHANICAL SEAL REQUISITION HISTORY FOR FF-1052 CLASS SHIPS

3.2.3.4.4 Mechanical Seal Requisitions. Mechanical seal requisition data, as presented in Figure 3-7, are known to understate the usage of this item since the ships initially used spares provided with mechanical seal conversion kits. Also, it must be noted that the data are not normalized to the number of pumps using mechanical seals, and thus the rise in requisitions as installations progress is to be expected. The latest data available show increasing requisitions, exceeding one seal per ship operating quarter.
